Perle 594M Diagnostic Guide

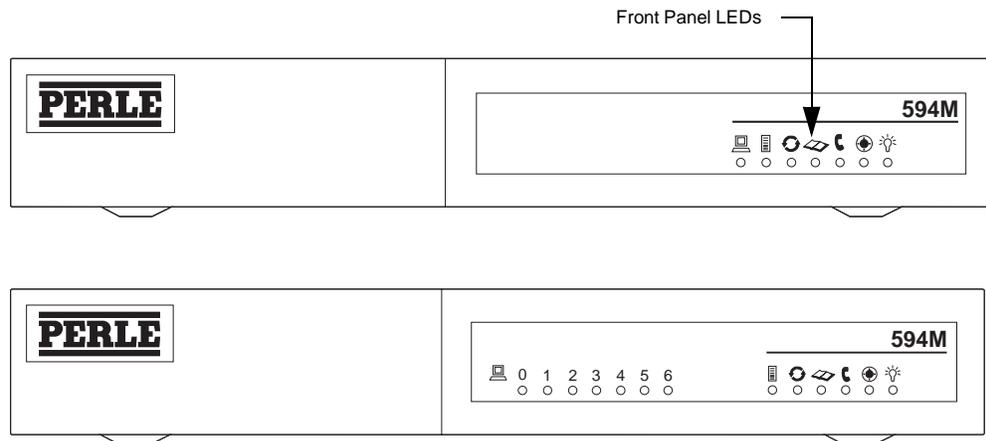
Perle 594M Front View

The Front View diagram shows the two versions of the 594M front panel. The top model is equipped with a single twinaxial turret interface with the single Twinaxial LED on the front panel. The second model is equipped with 7 twinaxial TTP interfaces and 7 Twinaxial LEDs on the front panel

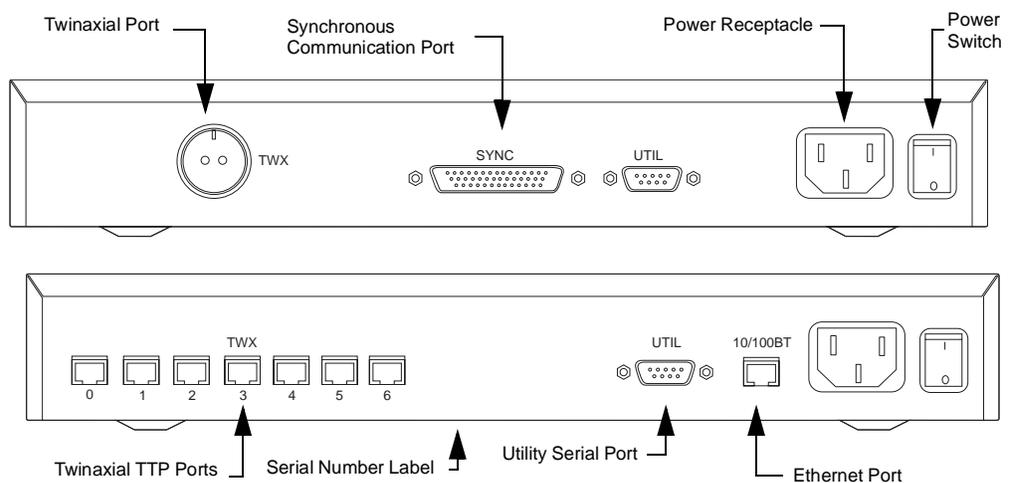
Perle 594M Rear View

The following diagrams show the location of the major hardware components of the Perle 594M.

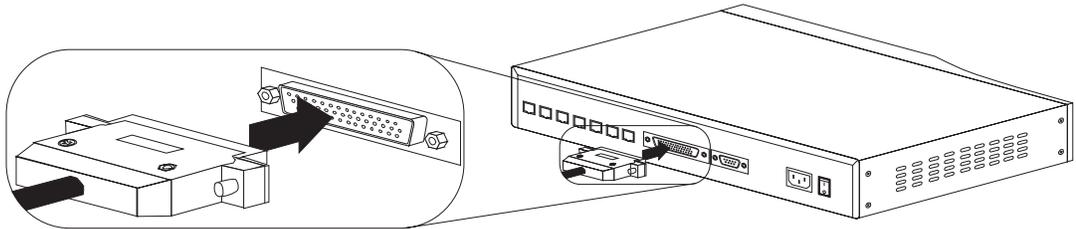
1. Disconnect the communication cable from the Synchronous Communication Interface.

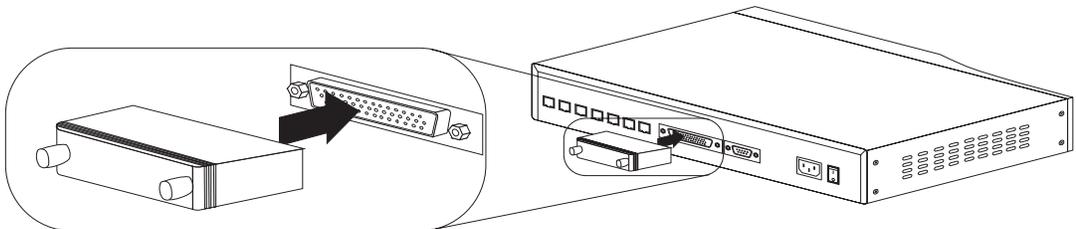
2. Connect the loop-back header to the Synchronous Communication Interface.
